PREWITT AND ASSOCIATES INC AUSTIN TX

**A PRELIMINARY ASSESSMENT of the CULTURAL RESOURCES in  
the BRAZOS NATURAL SALT POLLUTION CONTROL PROJECT,  
KENT, KING and STONEWALL COUNTIES, TEXAS**

**REPORTS OF INVESTIGATIONS, NUMBER 18**

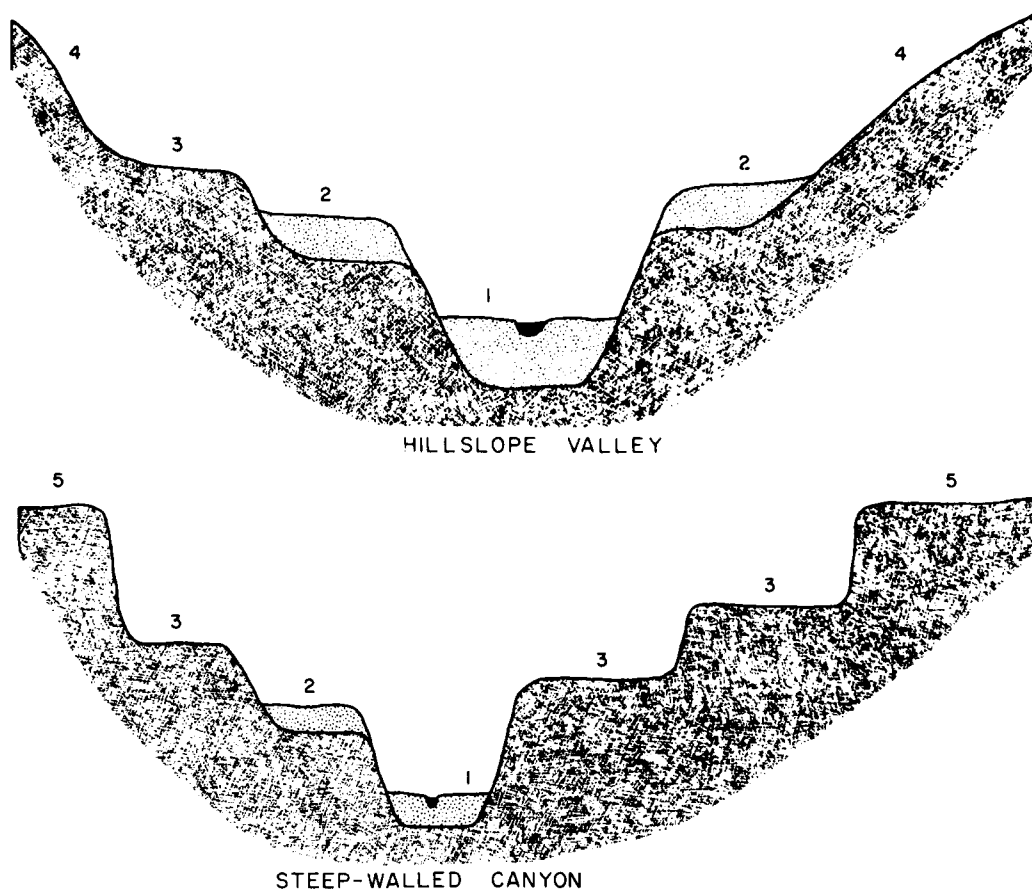
## GENERALIZED PHYSIOGRAPHIC PROFILES

- 1 Modern Channel & Floodplain
- 2 Alluvial Terrace
- 3 Bedrock Bench
- 4 Valley Margin Slope
- 5 Canyon Rim

The physiography of the project area is primarily a product of fluvial and erosional processes and has been profoundly influenced by the composition of the outcropping bedrock. On an areawide level of generalization, the topography is characterized by broad, gently rolling upland areas which are broken by occasional escarpments and badlands along the outcrop lines of particularly massive and resistant beds of gypsum or dolomite, and dissected stream valleys which are often relatively deep and narrow.

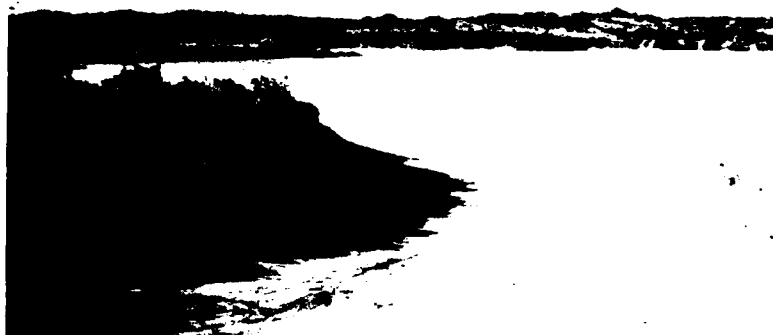
Figure 3

b. View east-southeast, downstream along Croton Creek, from the northwestern corner of Survey Unit A-33. An outcrop of the Eskota Gypsum of the Whitehorse Group has formed a well-defined canyon rim, with steep scarps down to the valley floor. Lag gravels deflated from the 12 meter Croton Creek terrace, recorded as locality L41KT9, occupy the canyon rim at left. Virtually all of the alluvium in view along the canyon floor is of late Holocene to very recent origin.

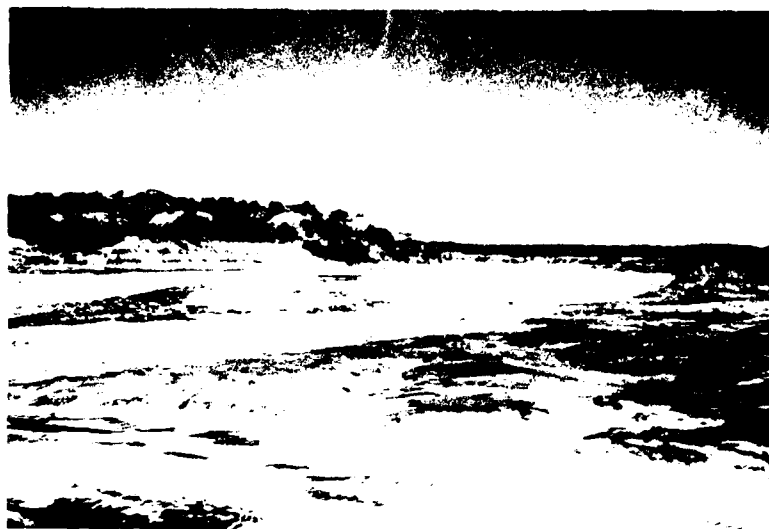
Figure 4

b. Facing west across a short tributary of Southerland Creek, at the northern end of locality L41KG14. Notice how the gently rolling uplands in the background dramatically give way to a relatively steep-walled canyon, and the series of shelving bedrock benches which lie between the canyon rim and the stream channel. The bedrock is complexly interbedded gypsum and shale of the Permian Blaine Formation. This stream is spring-fed by the upper groundwater unit, and its water is relatively fresh.

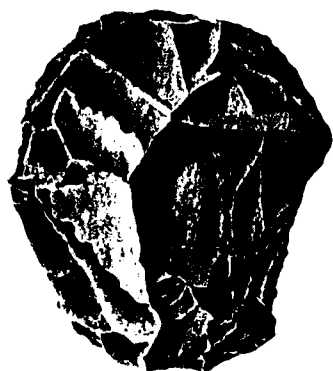
*a*

Figure 16. Planoconvex Unifaces.

The first specimen was recovered from the surface of 41KT24 (Fig. 16a). It was manufactured from a very thick, cortex-platform, hard-hammer percussion flake of light gray aphanitic chert. The specimen was percussion flaked into a truncated ovaloid form with a strongly convex bit at the distal end. Retouch along that end and along the left edge has produced an extremely steep (75-80°) shelving edge. The apices of both retouched edges exhibit a light polish. This is by far the thickest of the unifaces and is morphologically similar to specimens casually

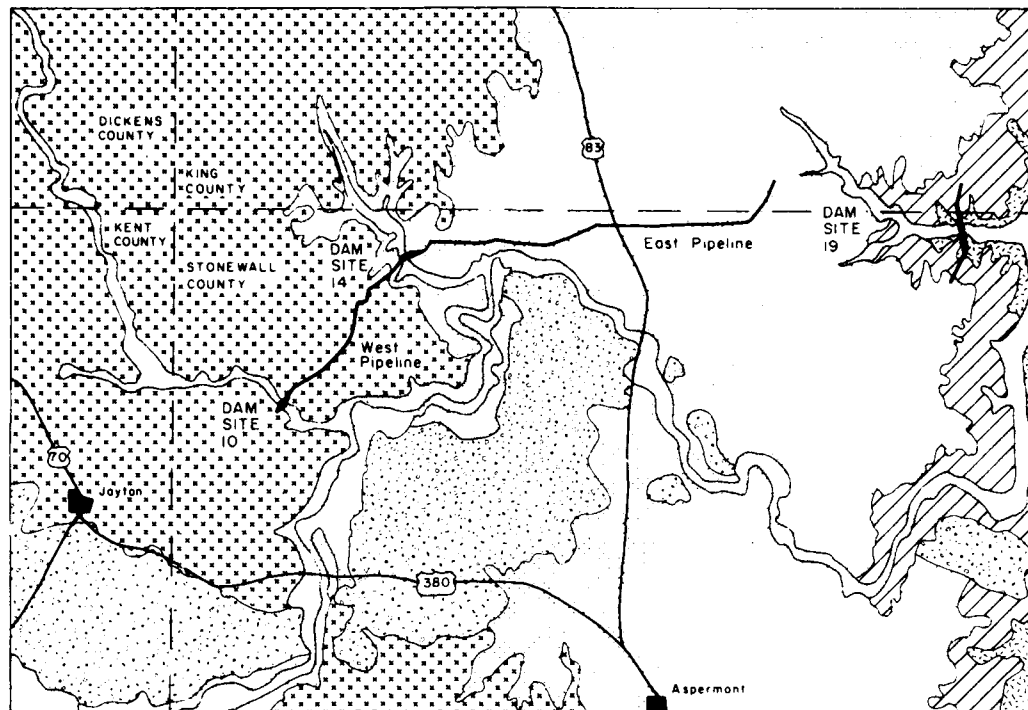
Figure 18

# BRAZOS NATURAL SALT POLLUTION PROJECT KENT, KING & STONEWALL COUNTIES, TEXAS OUTCROP LITHOLOGY

- Whitehorse Group
- Blaine Formation
- San Angelo Formation
- Choza Formation

The San Angelo Formation within the project area is predominantly a red (sometimes gray), fine-grained quartz sandstone and also contains red to bluish gray shales and conglomerates of dolomitic and siliceous limestone pebbles. The formation ranges from 15 to 40 meters in thickness (Barnes 1967; Patton 1930:21-24).

The landscape of areas where the San Angelo Formation crops out are usually open, level to gently rolling plains. In those areas where the unit contains indurated sandstone or thick conglomerate which are sufficiently resistant to form cliffs and steep-walled valleys, escarpments will occasionally interrupt the otherwise horizontal landscape.

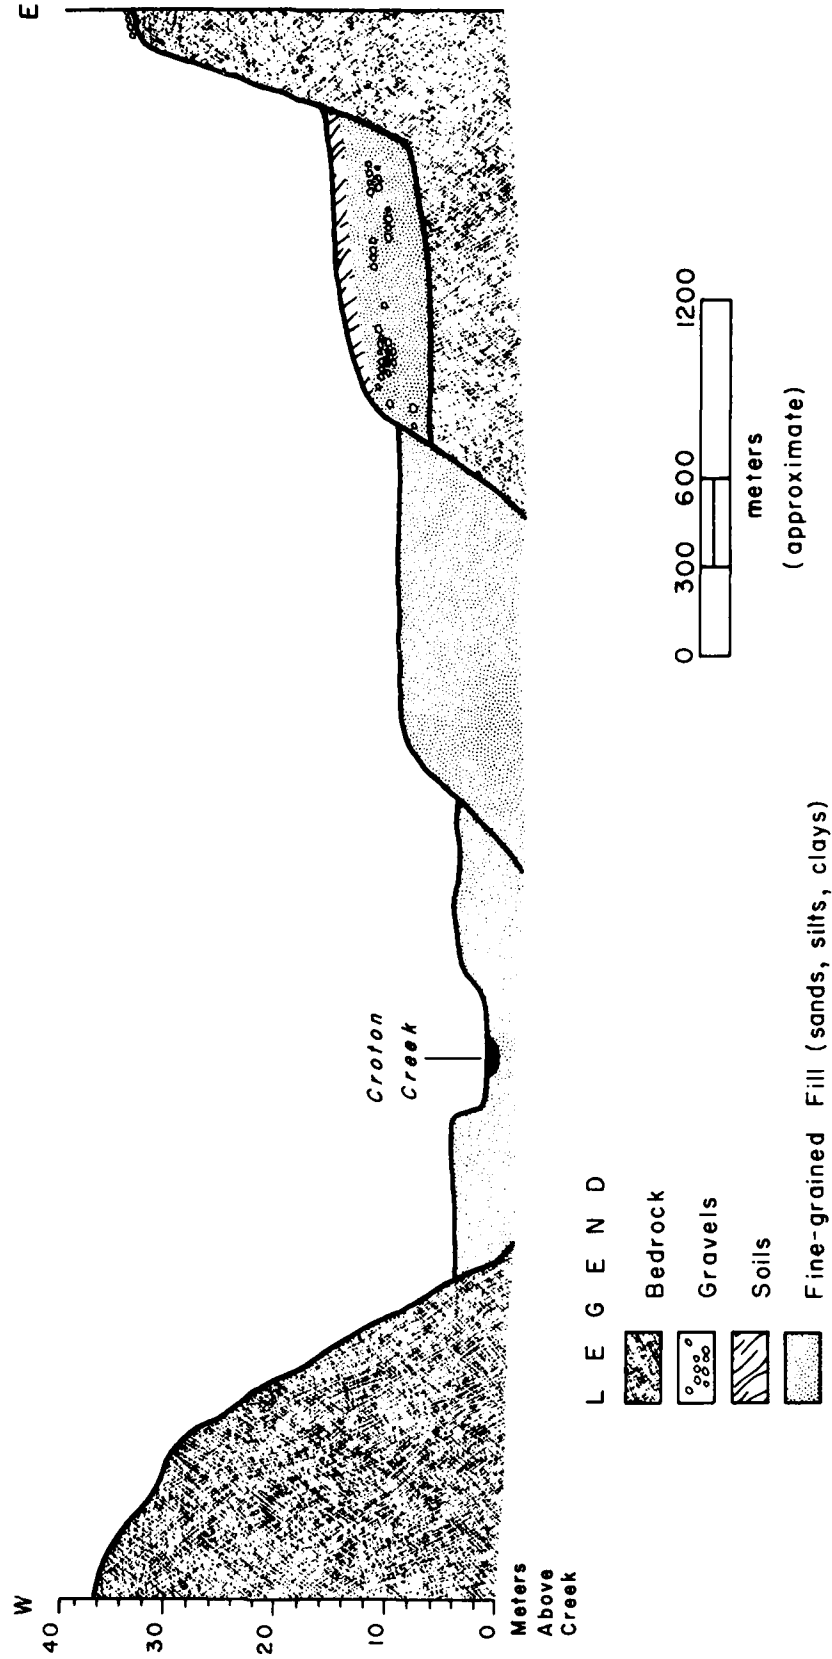
Figure 19

# BRAZOS NATURAL SALT POLLUTION PROJECT DAM SITE 10 GENERALIZED ALLUVIAL STRATIGRAPHY ALONG CROTON CREEK

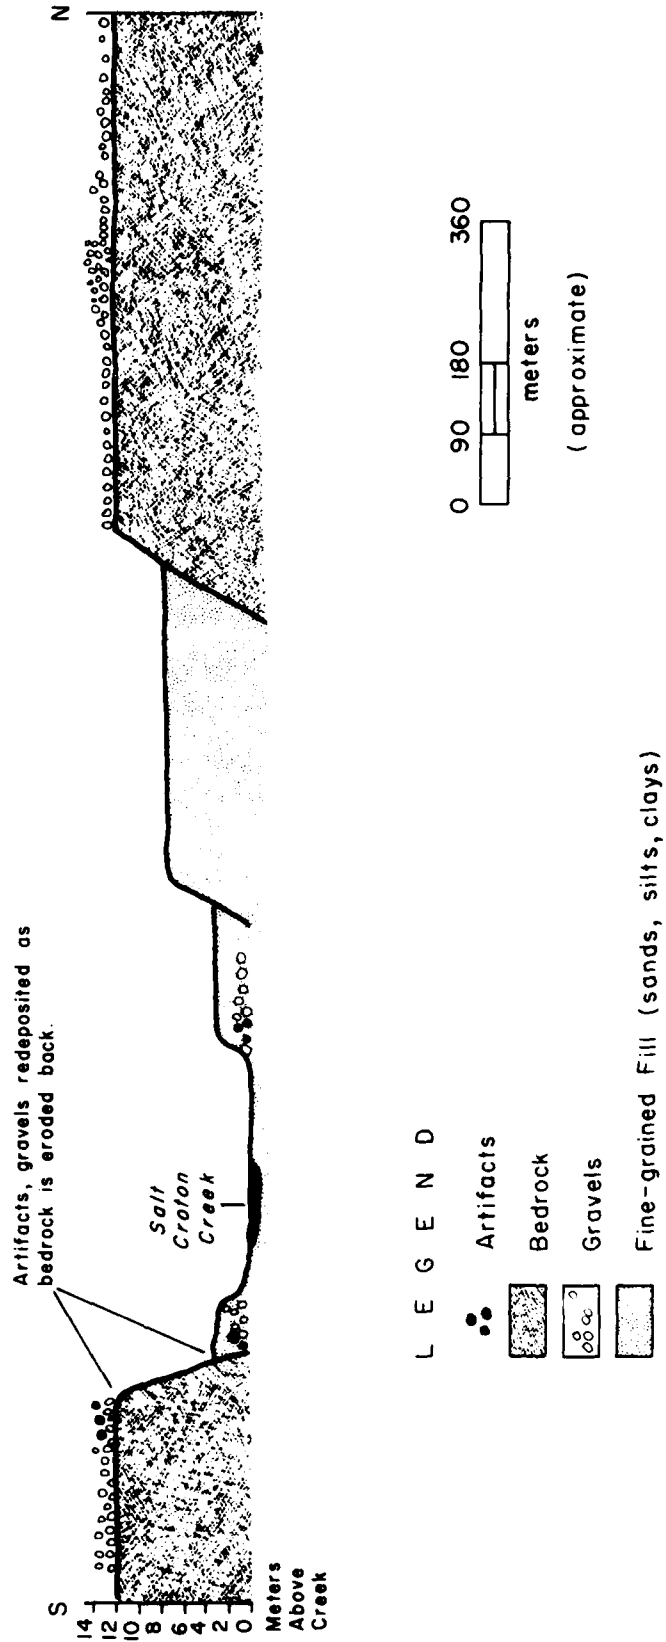
Figure 21

# BRAZOS NATURAL SALT POLLUTION PROJECT DAM SITE 14 GENERALIZED ALLUVIAL STRATIGRAPHY ALONG SALT CROTON CREEK

Three alluvial terraces were observed along Salt Croton Creek. Fill terraces occur at elevations of 1 to 3 meters and 6 to 9 meters above the modern floodplain. The lower of the two terraces appears to date to modern times; skeletal remains of modern domesticated animal species were observed eroding from the base of the terrace. The 6-to-9-meter terrace exhibits weak soil development and probably originated within the last few centuries. Finally, a high strath terrace at elevations greater than 12 meters appears to be of at least late Pleistocene age, and its gravels were also exploited aboriginally.

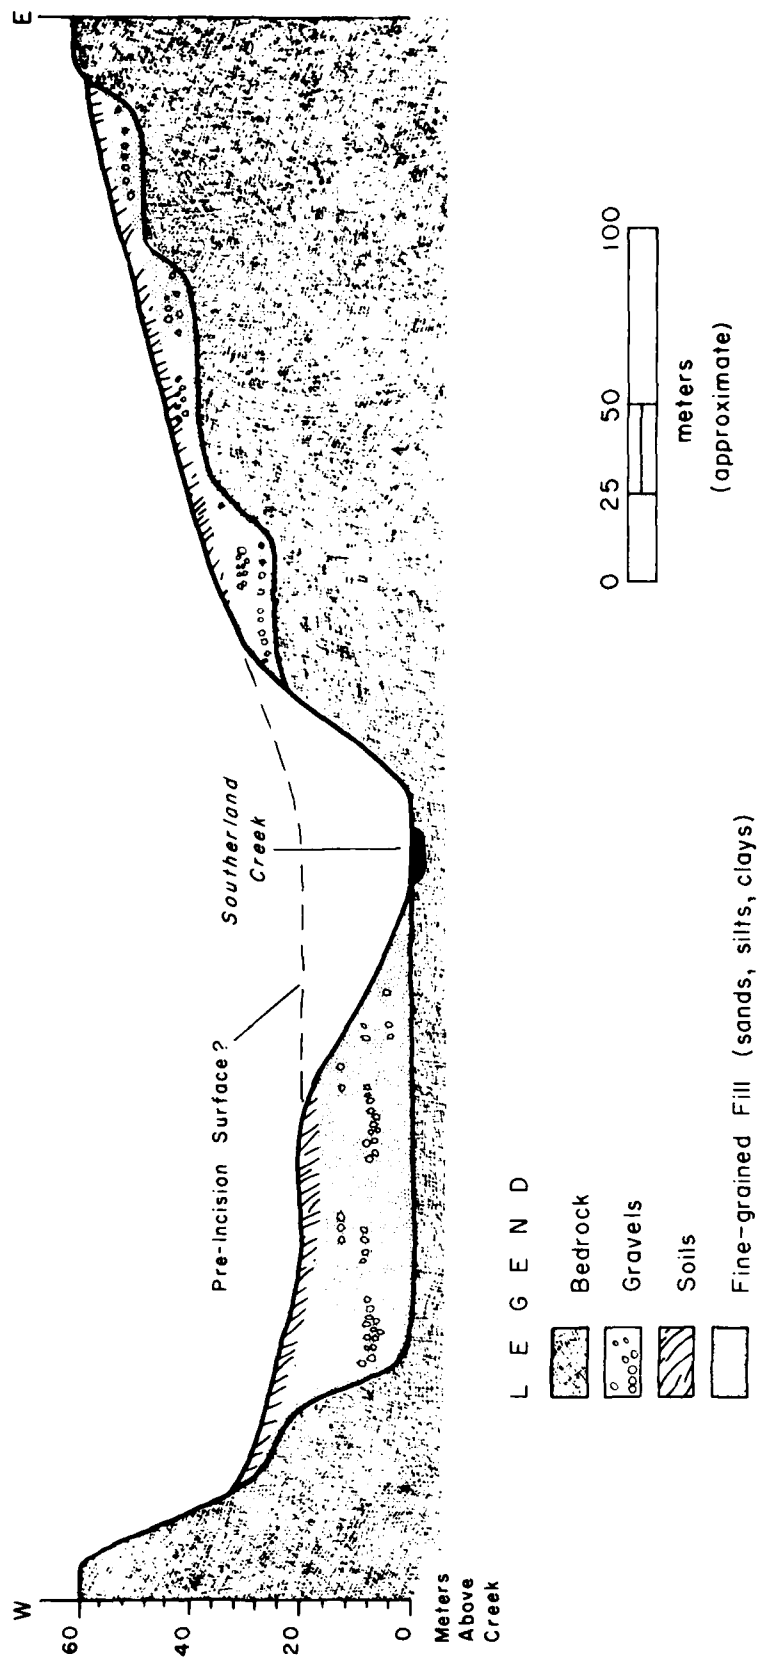
Figure 23

# BRAZOS NATURAL SALT POLLUTION PROJECT DAM SITE 14 GENERALIZED ALLUVIAL STRATIGRAPHY ALONG SOUTHERLAND CANYON

fill (with the well-developed soil) is traceable for approximately 3 kilometers along the valley floor; this deposit could contain archeological sites.

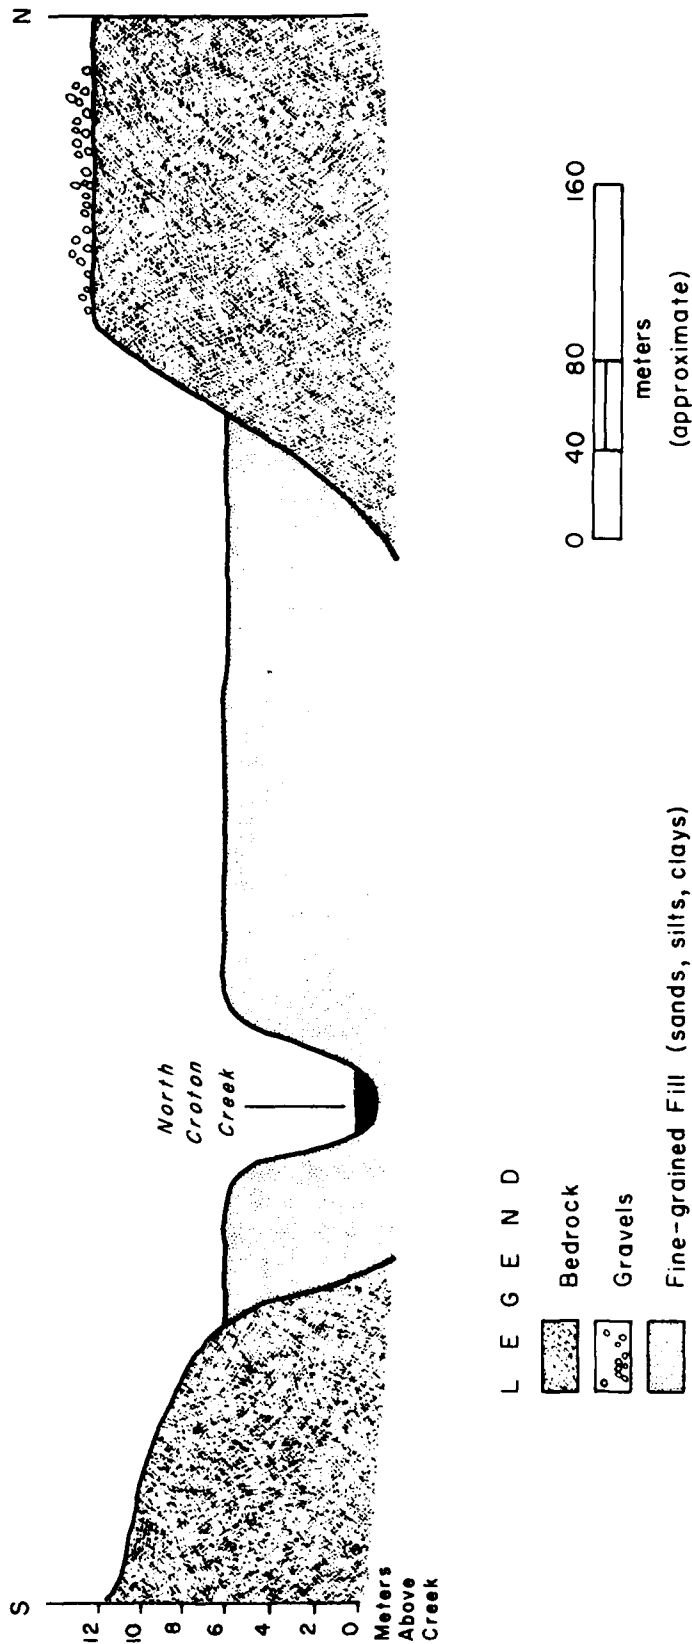
Figure 24

**BRAZOS NATURAL SALT POLLUTION PROJECT**  
**DAM SITE 19**  
**GENERALIZED ALLUVIAL STRATIGRAPHY ALONG NORTH CROTON CREEK**

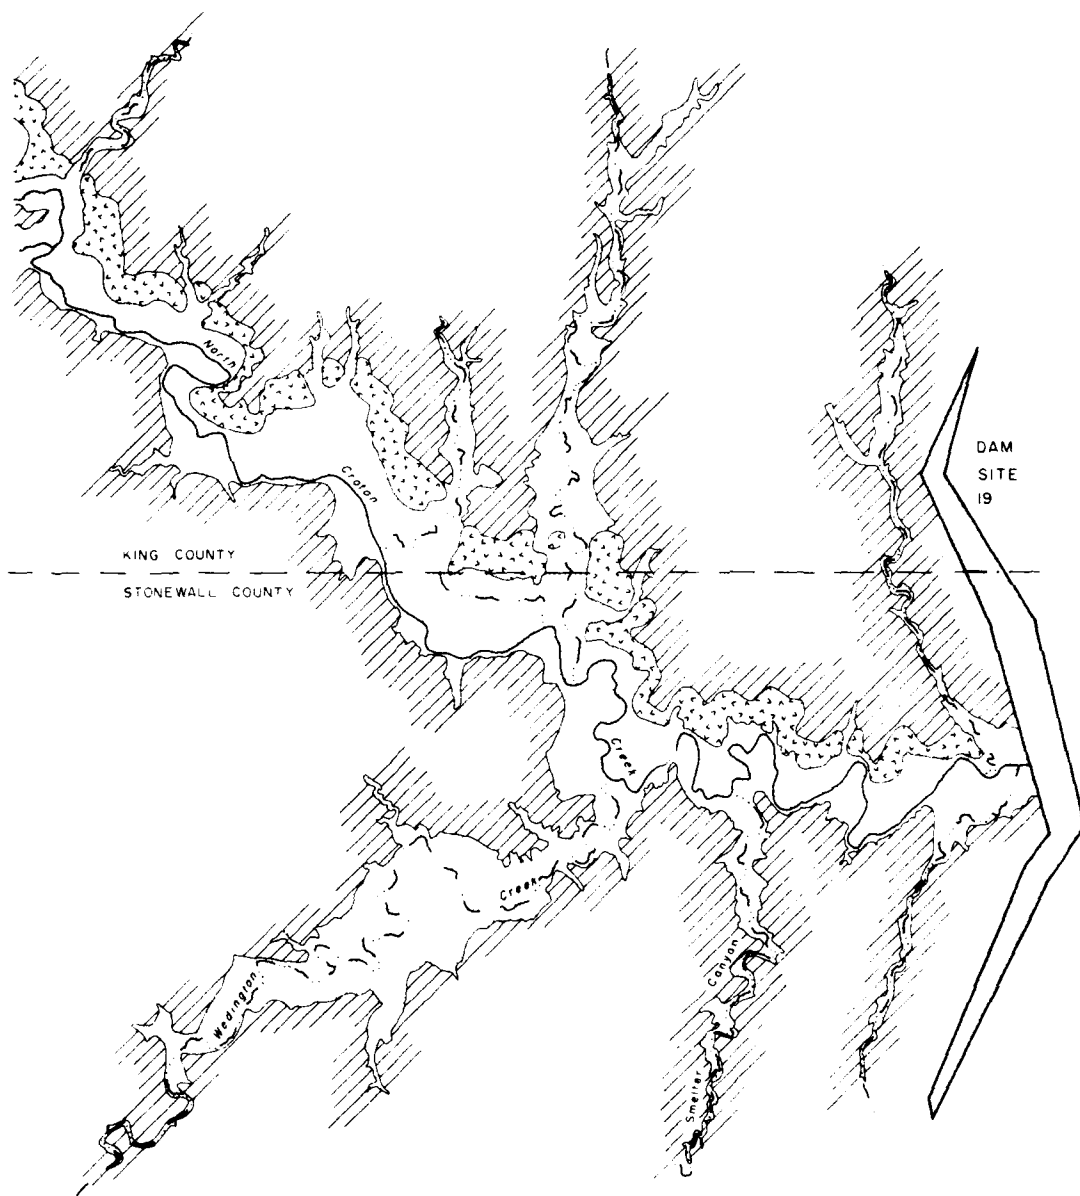
Figure 25

DISTRIBUTION OF ALLUVIAL DEPOSITS ALONG SELECTED SEGMENTS  
OF NORTH CROTON CREEK AND ITS TRIBUTARIES

LEGEND  
 Recent Alluvium  
 12-15m Strath Terrace  
 Permian Bedrock

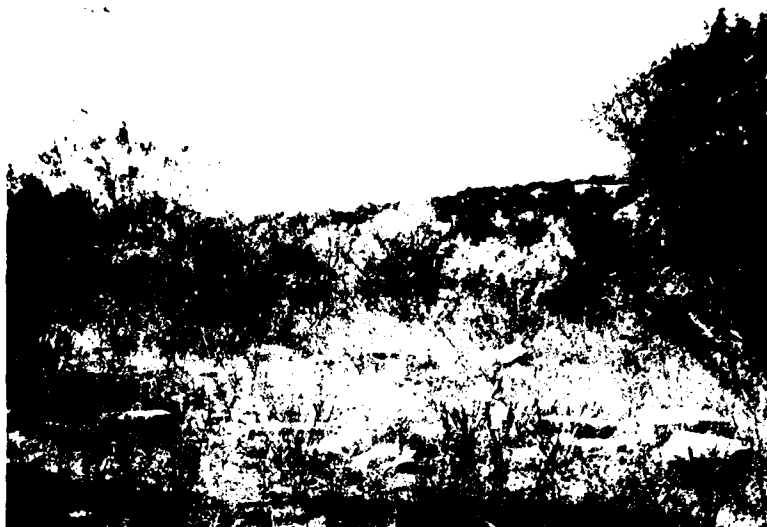
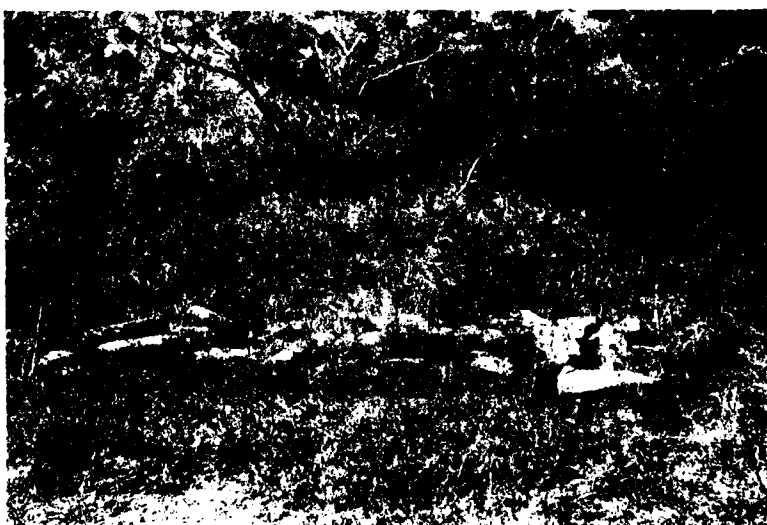
Figure 31

Figure 31. Wedington Spring and Kiowa Peak Copper Mine

a. A view to the southwest shows a freshwater spring in Wedington Canyon on the margin of the Dam Site 19 basin which has been a perennial cattle camp for almost a century. Documentary sources suggest that this spring, site 41SN71, or another one like it down canyon may have been used by the famous southwestern explorer Albert Pike in 1832.

b. A view east-southeast of site 41SN73, the Kiowa Peak Copper Mine. While this site seems to date from the early twentieth century, interest in the mineral resources of the Kiowa Peak area in northern Stonewall County began in the 1870s when representatives of the Washington Land and Copper Mining Company visited the vicinity and located claims in a dozen sections. The machinery at 41SN73 was eventually dismantled and moved to Aspermont, where it was reassembled and displayed on the courthouse lawn for a number of years.

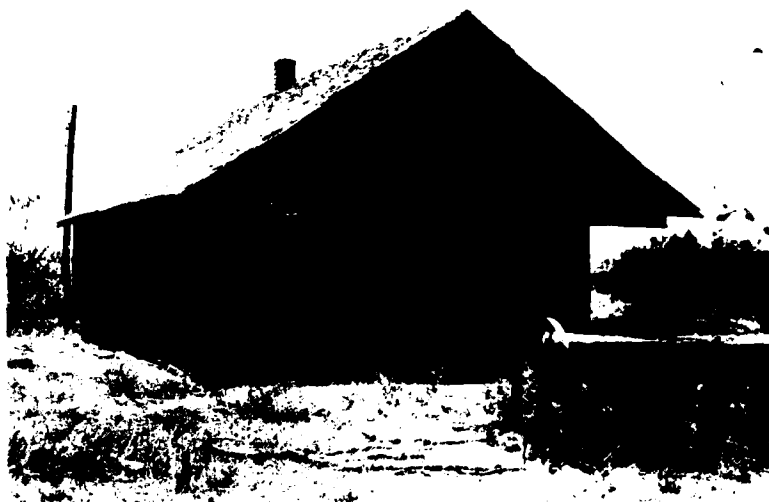
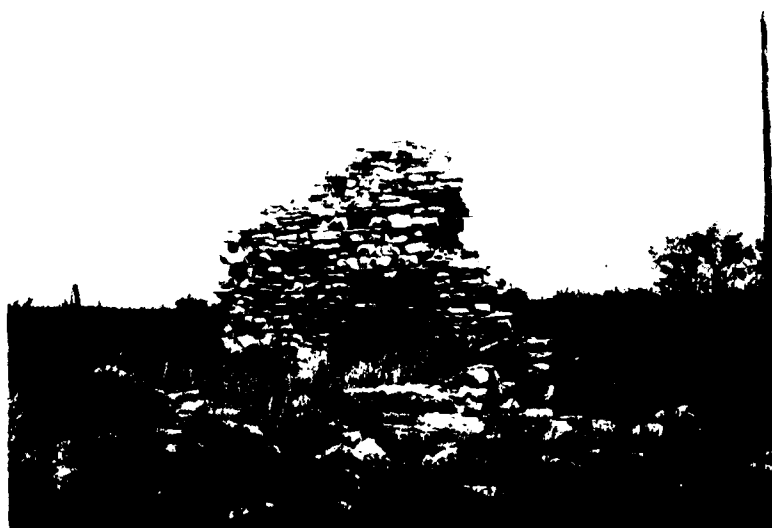
Figure 36

b. Despite its abundance in the Croton Breaks, stone was rarely used in dwellings. An exception is site 41KT22, the McLain House, which was also built in the 1920s. A view from the south illustrates a standing chimney and the only relatively intact wall of what was once a one-room house with a wood frame porch on the east side.
